INSTRUCTION REPORT M-78-1

GUIDE FOR AIRBORNE INFRARED ROOF MOISTURE SURVEYS

by
L. E. Link, Jr.

Mobility and Environmental Systems Laboratory
U. S. Army Engineer Waterways Experiment Station
P. O. Box 631, Vicksburg, Miss. 39180

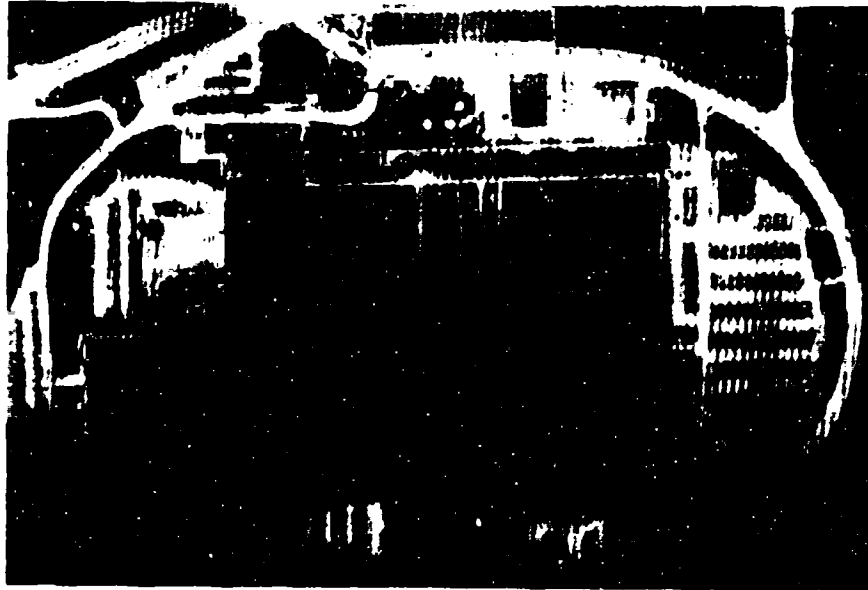
NOTE: V = air vent.
M = entrapped moisture.
SW = standing water.

Figure 13. Suggested format for documenting roof moisture conditions

38. A permanent record should be maintained for each roof (especially those determined to have entrapped moisture). Figure 13 shows a possible format. The top part of the figure is a photographic enlargement of the thermal IR image of the roof. The bottom part is a scale drawing showing anomalies on the imagery and the causes of the anomalies. Such a record would help in interpreting future thermal IR imagery of the same roof, providing a record of conditions when the imagery was obtained, and providing a mechanism to monitor expansion of entrapped moisture or effectiveness of repairs.
